Assessment of Dam Safety of Coal Combustion Surface Impoundments

Coletto LP, LLC

Coletto Creek Power, LP

March 11, 2011

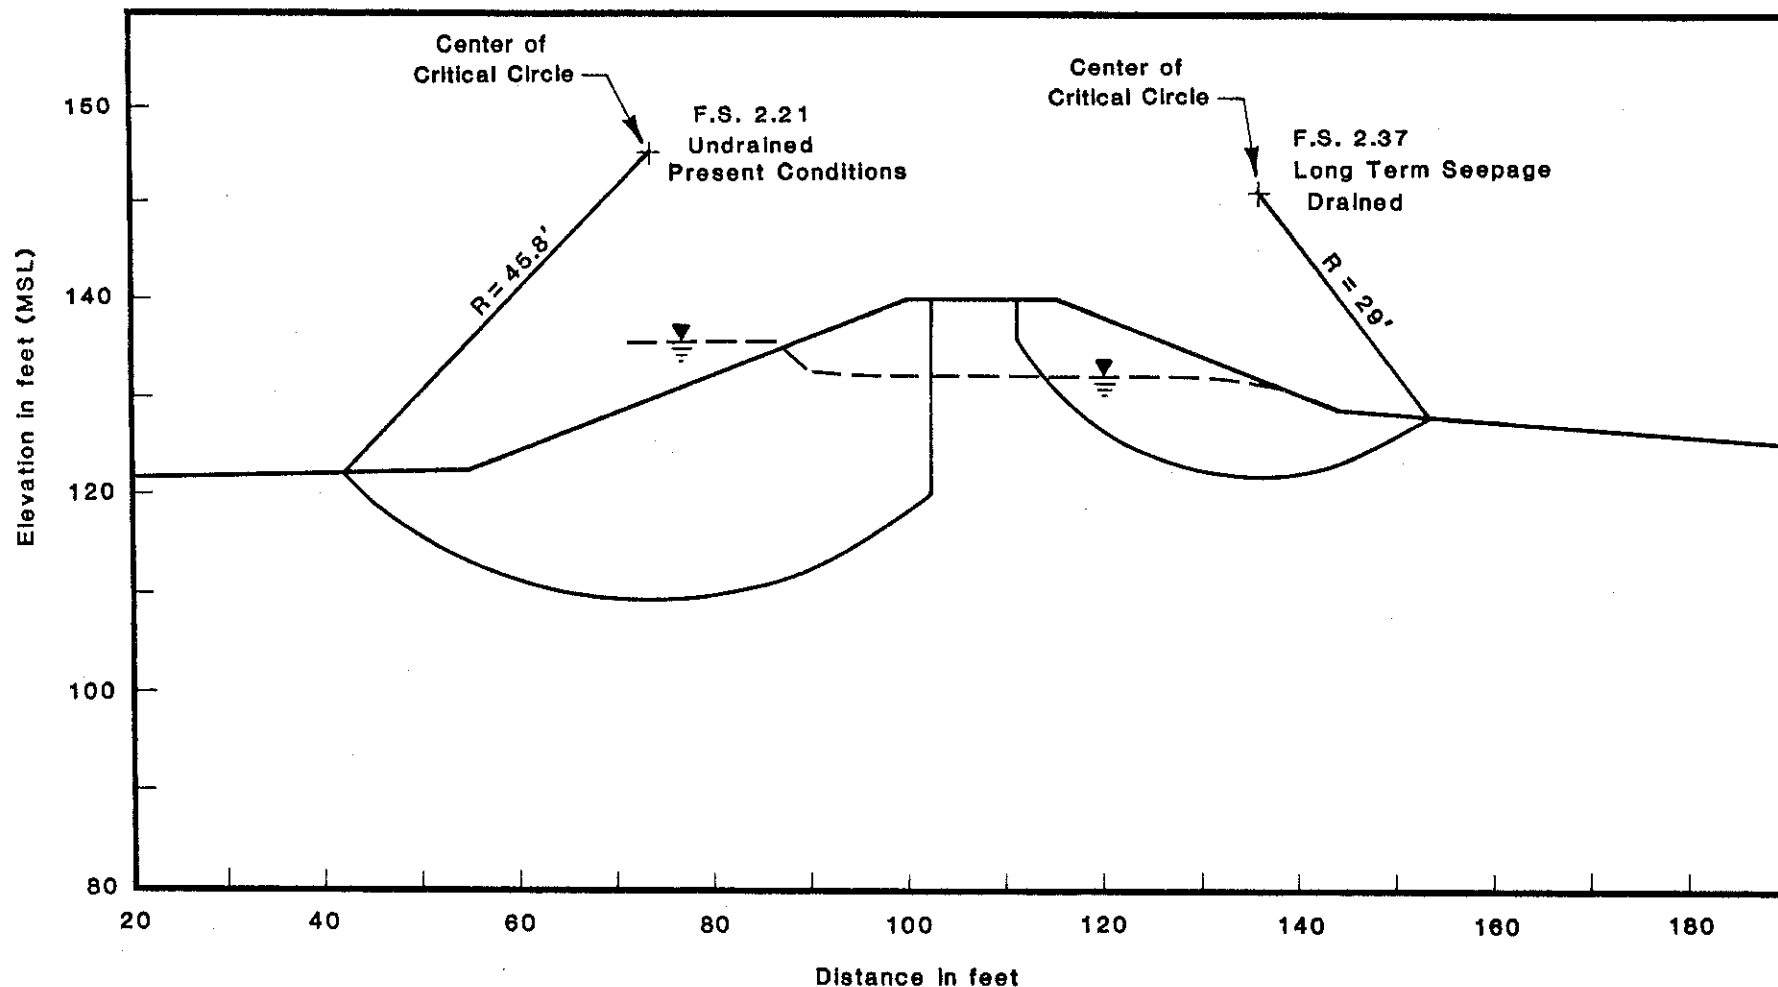
PRIMARY ASH POND
EAST EMBANKMENT STABILITY ANALYSIS
FIGURE 9

The interior slope of the Primary Ash and Secondary Pond was evaluated under undrained conditions. URM performed the analyses assuming a pond water level of El. 125. Although not specifically indicated, it appears that this analysis may have been selected to model a drawdown condition. The results of the undrained analysis for the primary ash and Secondary Pond embankments are shown on [Figures 9](#) and [10](#), respectively. Figures 9 and 10 indicate the factor of safety against slope stability was 2.21 and 1.87 for the primary Ash and Secondary Pond interior slopes, respectively.

The exterior slope of the Primary Ash and Secondary Pond was also evaluated under long-term steady-state conditions assuming a normal pool elevation of El. 135. For the steady-state analyses, URM assumed effective soil strength parameters. The results of the drained analysis for the Primary Ash and Secondary Pond embankments are shown on Figures 9 and 10, respectively. Figures 9 and 10 indicate the factor of safety against slope stability was 2.37 and 1.68 for the Primary Ash and Secondary Pond exterior slopes, respectively, which is greater than the minimum required 1.5. It

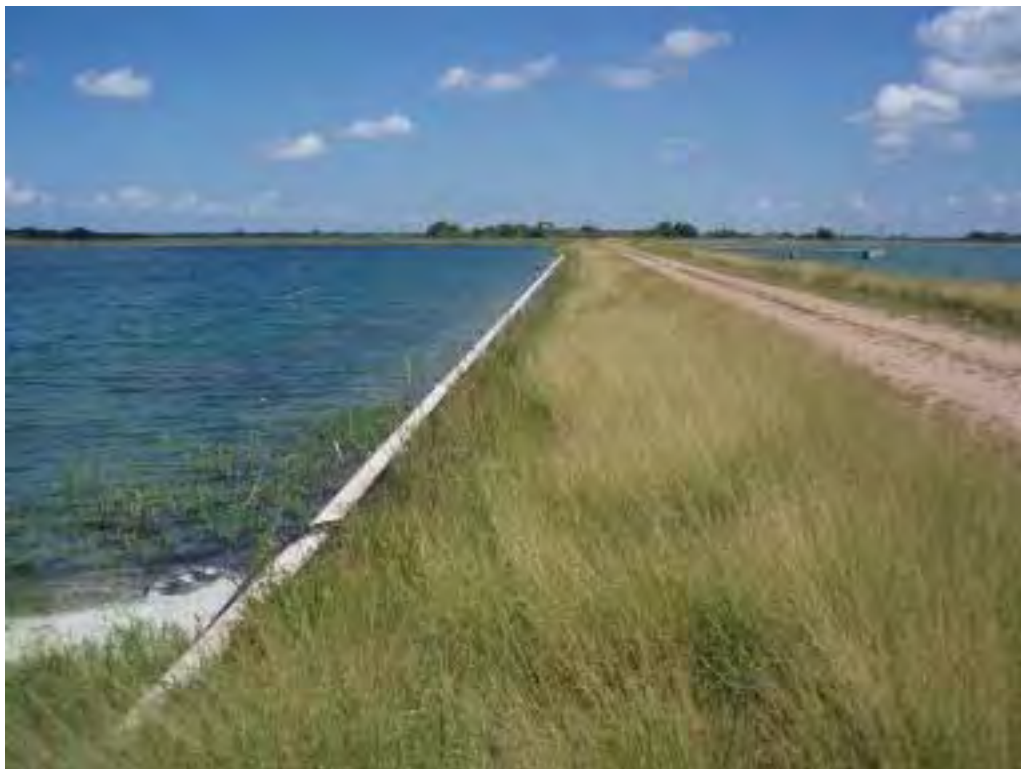
The visible portions of the interior slope generally appeared to be in fair to poor condition (Photos 1, 15, 42, 43, 46, and 47). The interior slopes on the north and east embankments and the northeast slope of the divider embankment were approximately 3H: 1V.

The 8-inch-diameter discharge pipe from the recirculating pump station was observed on the northeast slope of the divider embankment (Photos 1, 4, and 15). The discharge pipe was supported on concrete piers spaced at approximately 10 feet on center.

Photo No. 1: Secondary Pond - Northeast slope of divider embankment from northwest corner, looking southeast.

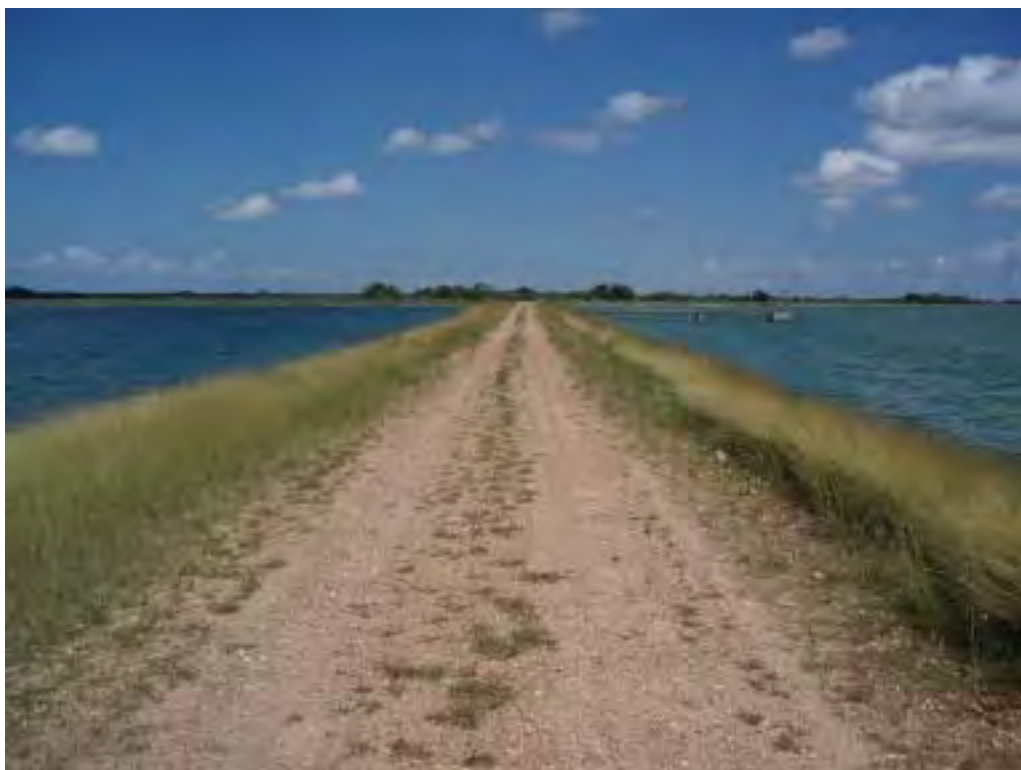
The crest of the Secondary Pond embankments appeared to be generally in fair condition (Photos 2, 14, 17, 41, 46, and 47). The crest was generally approximately 20 feet wide. The crest is surfaced with compacted gravel and is used as an access road. Sparse vegetation was growing in the middle and on both sides of the roadway. A barbed wire fence used to contain livestock was observed on the north and east embankment crest perimeter (Photos 46, 47, and 48). The vertical alignment of the fence posts was in good condition. Observed freeboard at the time of the visit was approximately three feet.

Photo No. 2: Crest of divider embankment from northwest corner, looking southeast.

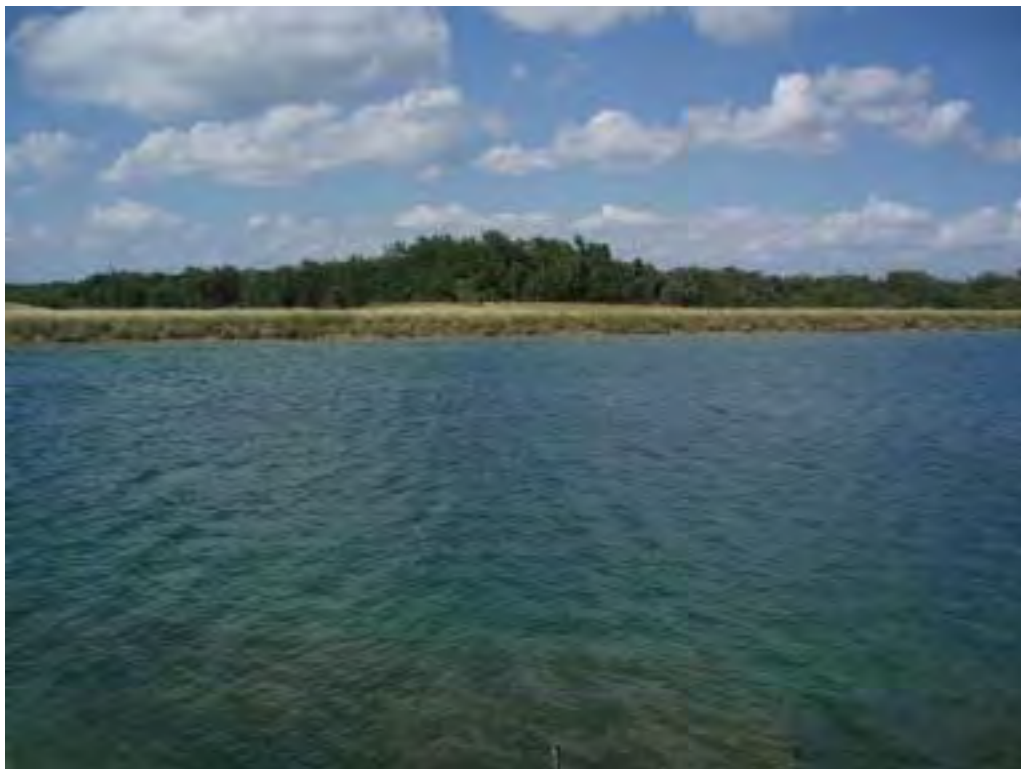
No riprap was observed on the interior slopes. Grass and brush approximately 24 to 36 inches tall was observed growing on the top 1 to 2 feet. Below, the soil was exposed and there was approximately 1 to 2 feet of erosion from wave action (Photos 4 and 43).

Photo No. 5: Secondary Pond - Overview of north interior slope, looking north at typical erosion from wave action. Note approximately 1 to 2 feet of erosion on north interior slope.

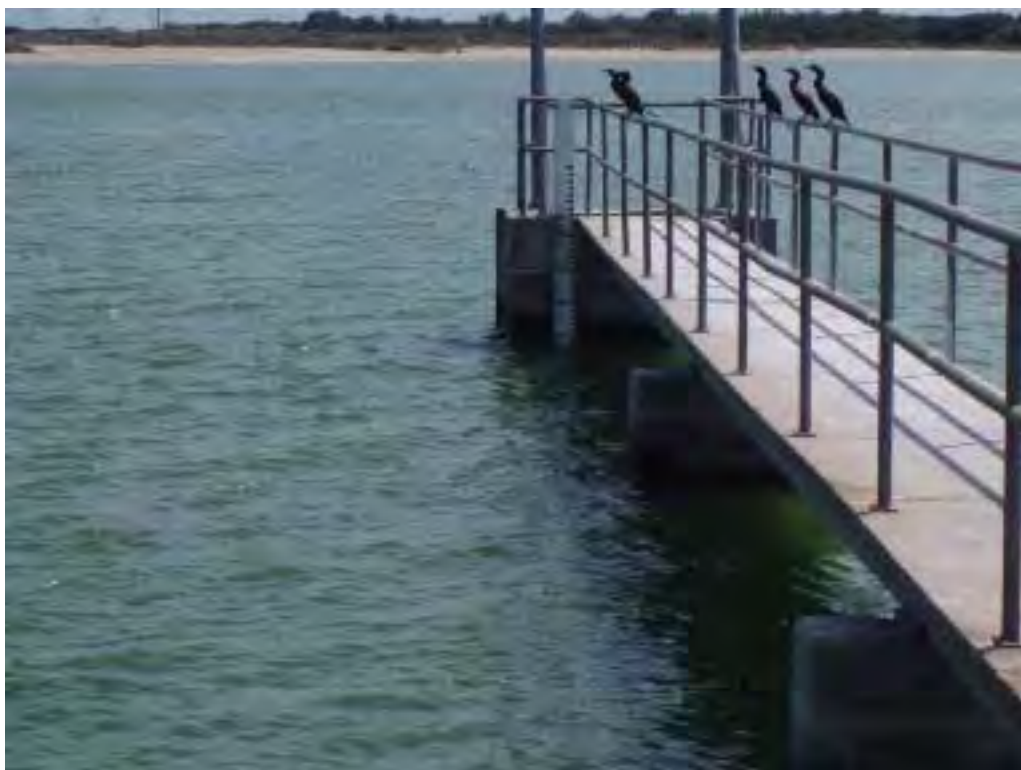
There is a staff gage on the inlet structure that is used to measure the impoundment water level elevation (Photos 6 and 8). Based on information provided by IPA personnel, the pond water levels are monitored daily. The pond water level during the site visit was at El. 136.8.

Photo No. 6: Primary Ash Pond - Overview of staff gage and inlet structure, looking southwest. Note water level on 6/21/10 and 6/22/10 was El. 136.8

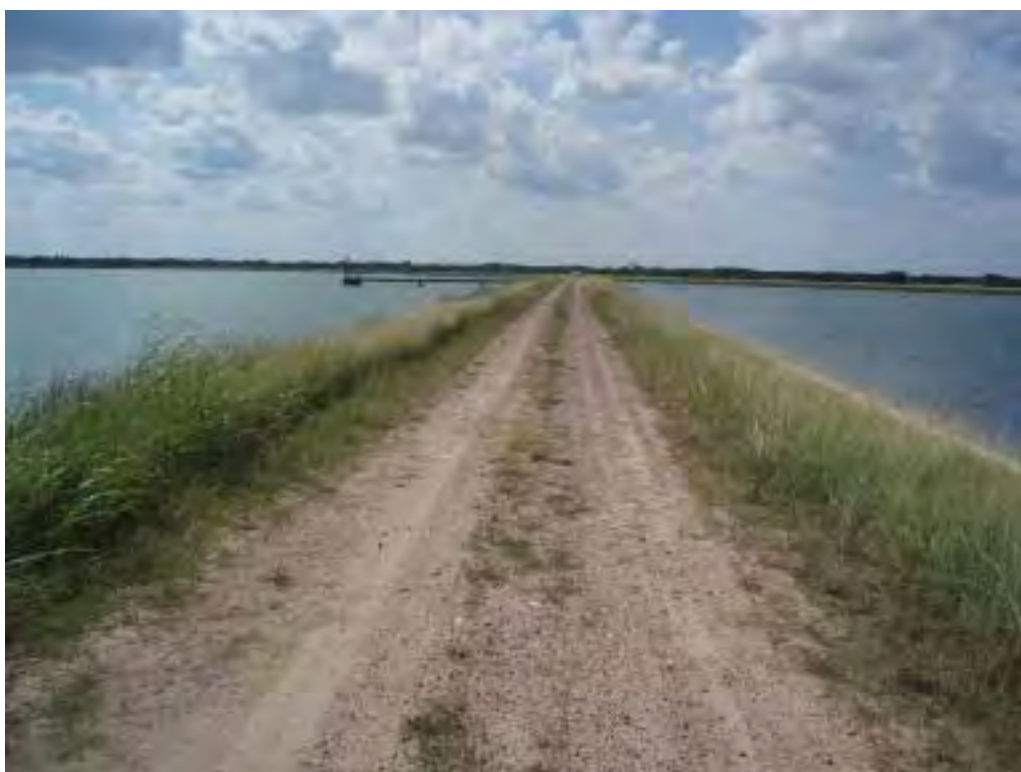
Photo No. 14: Crest of divider embankment, looking northwest.

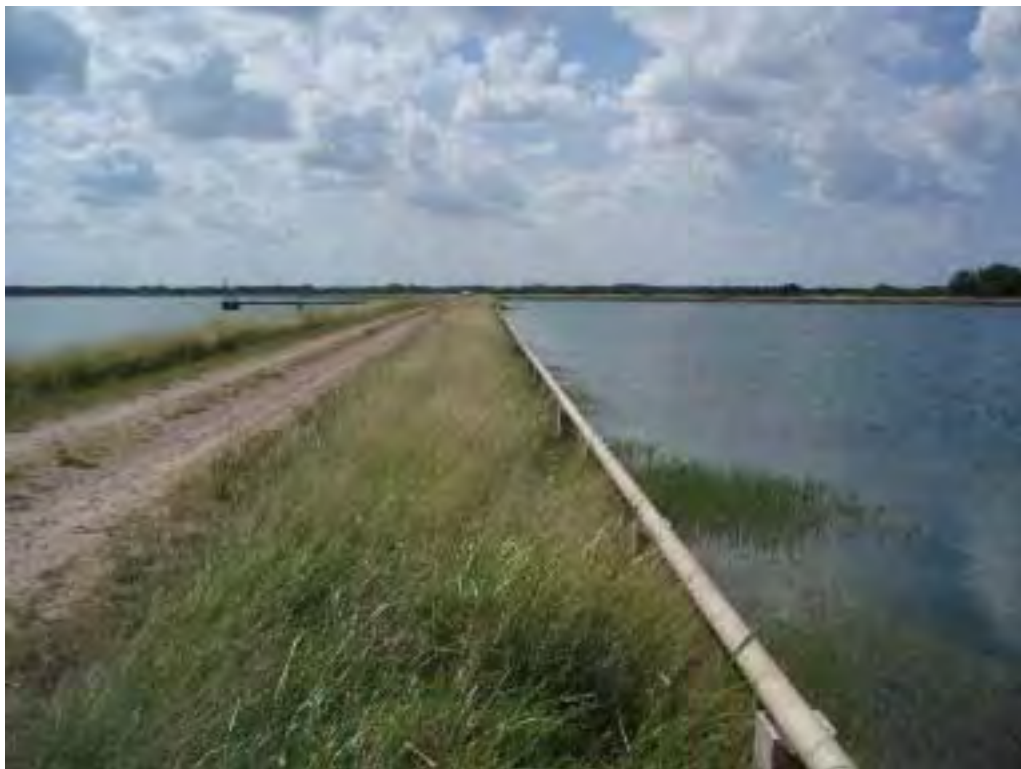
Photo No. 15: Secondary Pond - Northeast slope of divider embankment, looking northwest.

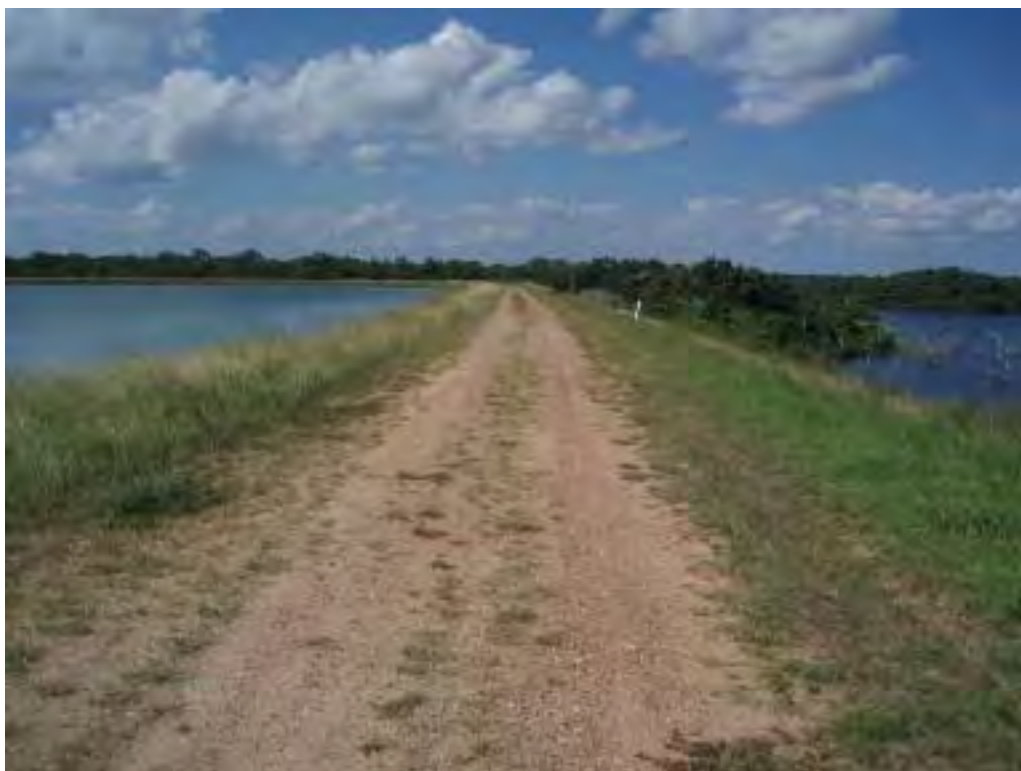
Photo No. 17: Secondary Pond – East embankment crest, looking northeast.

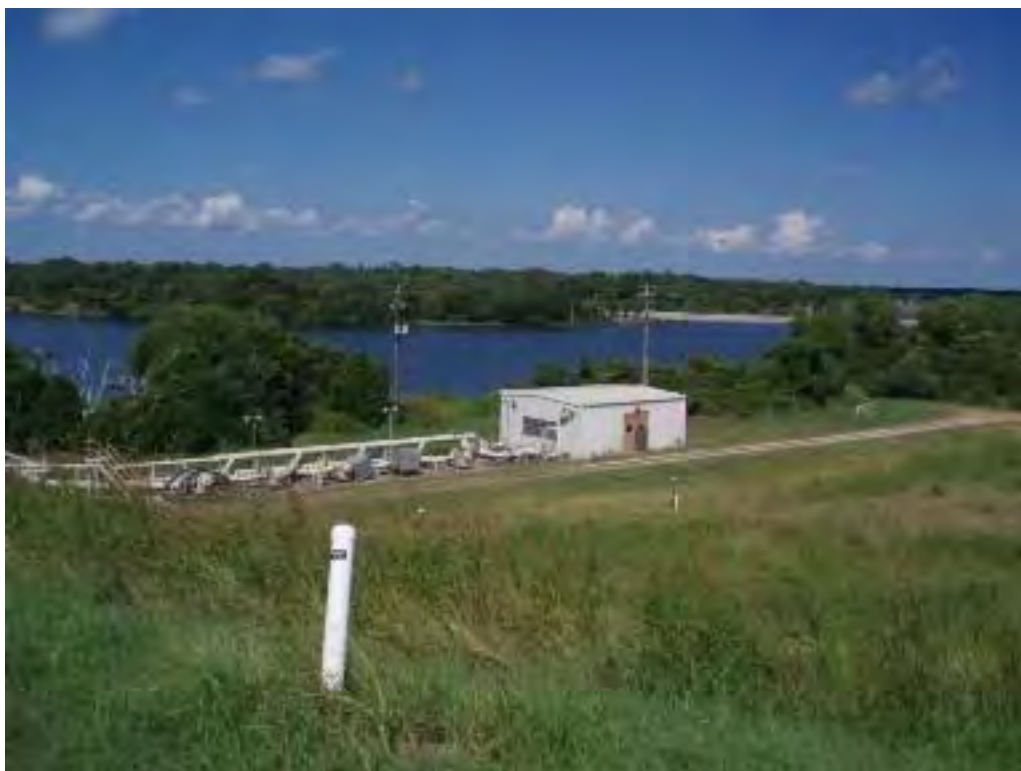
The outlet pipes and recirculating pump station appeared to be in fair condition (Photos 19, 20, 21, and 24). The outfall in the discharge canal appeared to be in poor condition (Photo 22). The discharge channel has deteriorated. The concrete is overgrown with vegetation, cracked and spalled, and sections of the channel are missing exposing the underlying soil.

Photo No. 19: Secondary Pond - East embankment downstream area, looking southeast at the recirculating pump station and Coletto Creek Reservoir.

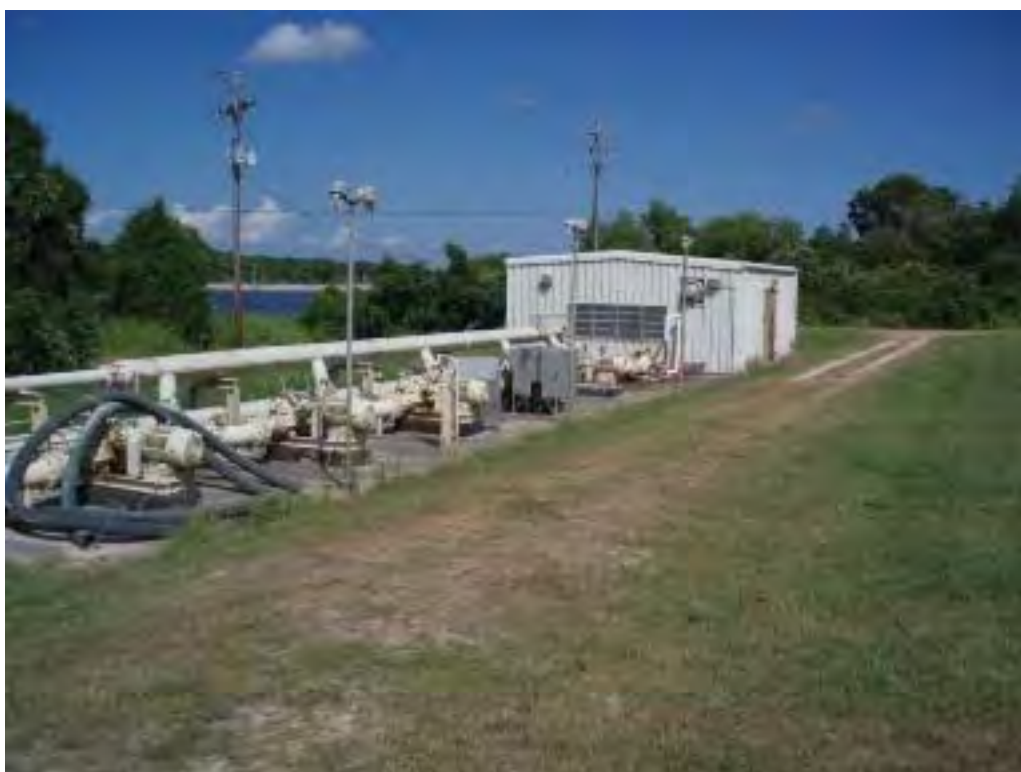
Photo No. 20: Overview of recirculating pump station, looking southeast.

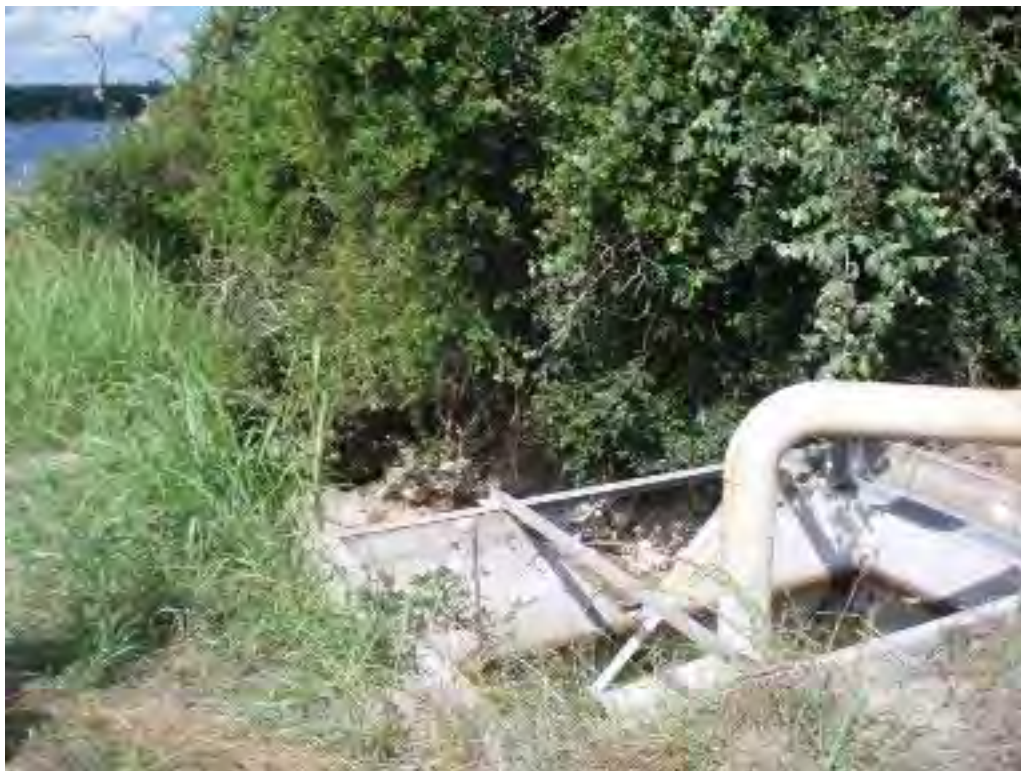
Photo No. 21: Overview of secondary pond 8-inch-diameter Outfall 003 with weir box.

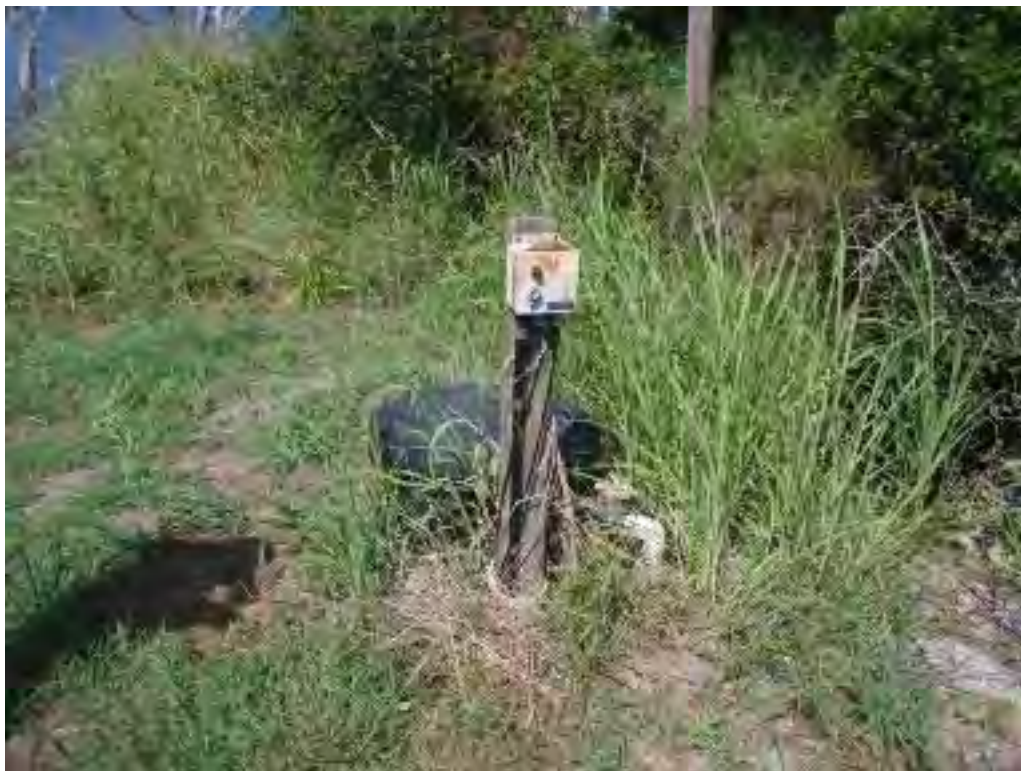
Photo No. 23: French drain discharge sump at toe of Secondary Pond near outfall. Estimated flow approximately 5 gpm through a 2-inch-diameter PVC pipe.

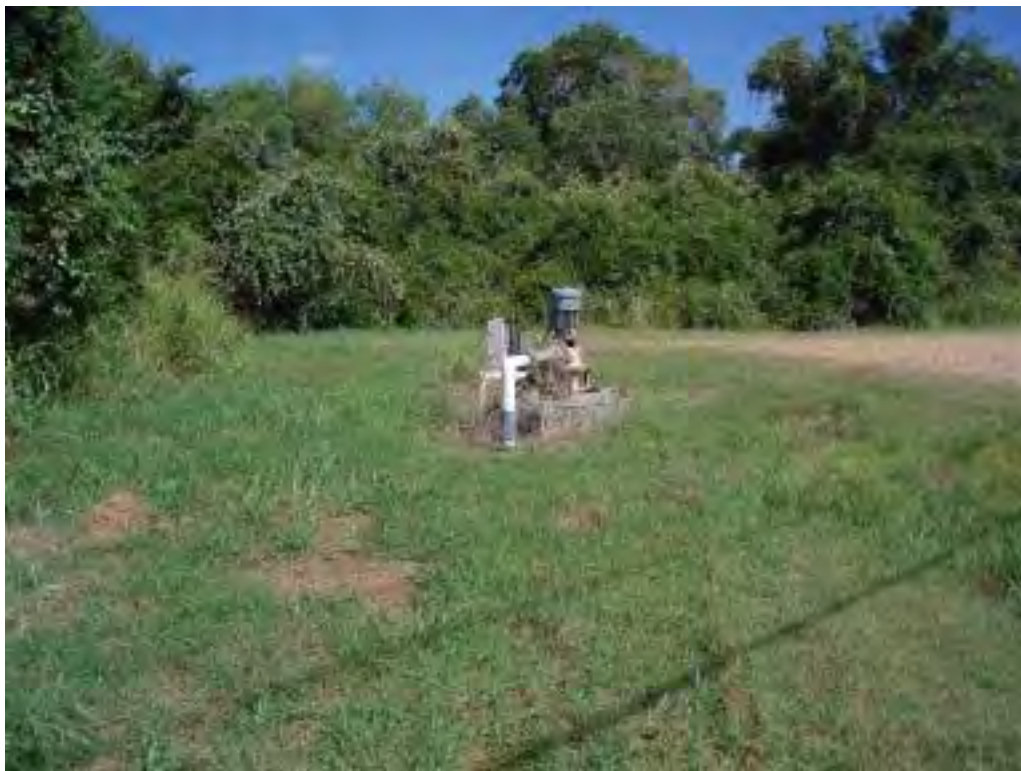
Photo No. 25: French drain discharge sump at toe of Primary Ash Pond east embankment.
Estimated flow approximately 50 gpm through a 4-inch-diameter PVC pipe.

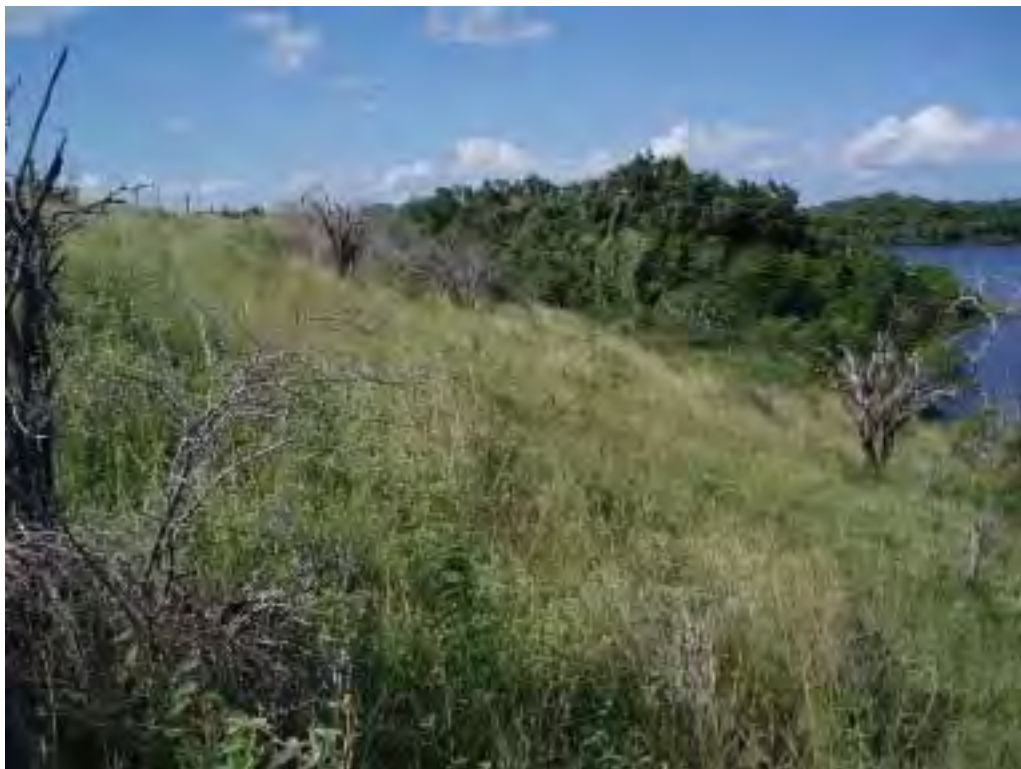
Photo No. 27: Secondary Pond - East embankment exterior slope looking northeast. Note 8- to 12-inch-diameter dead mesquite trees on the slope.

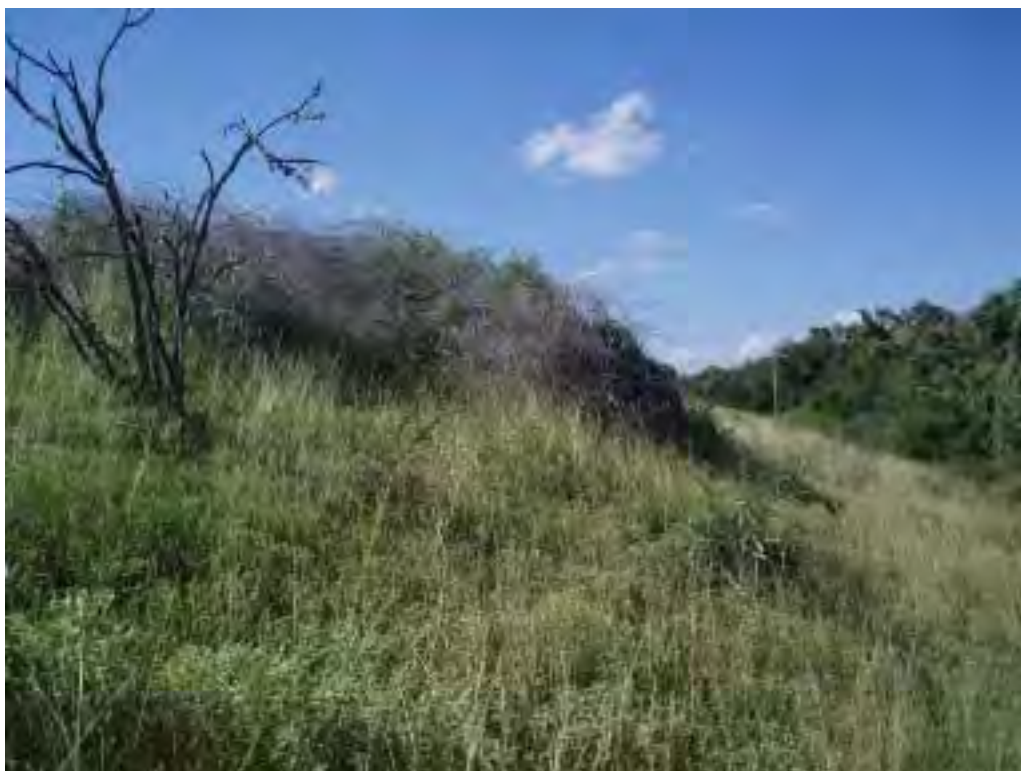
Photo No. 29: Secondary Pond - East embankment exterior slope, looking north at thick brush and dead trees.

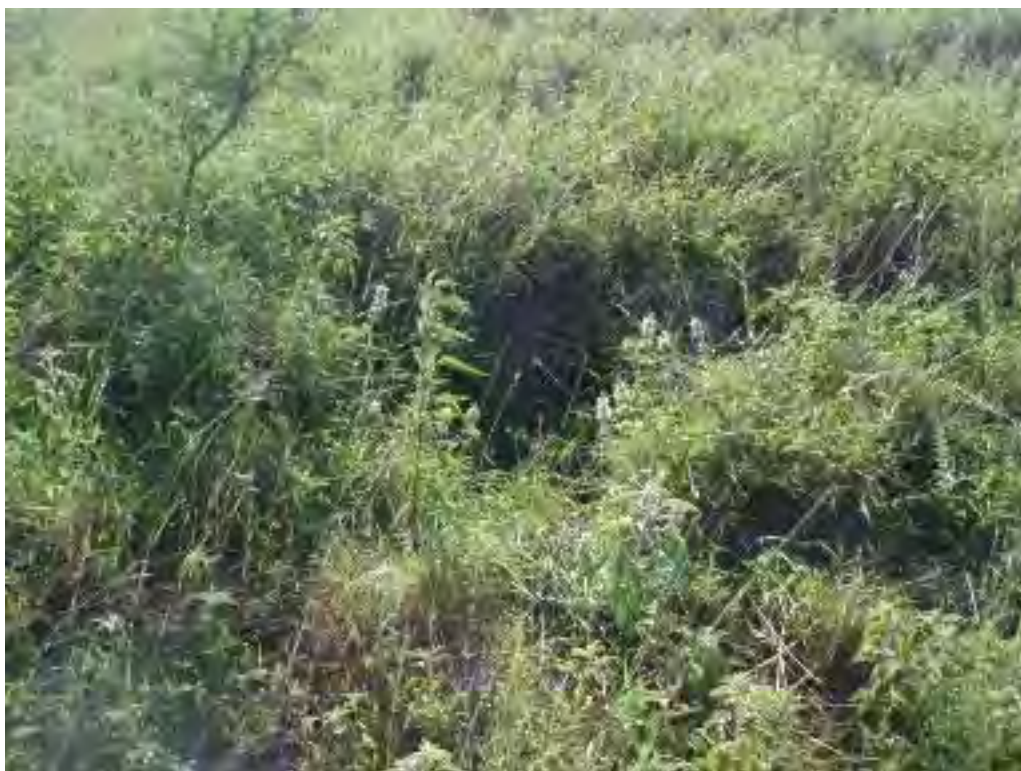
Photo No. 31: Secondary Pond - East embankment exterior slope, looking at 6'Lx4'Wx3'D depression.

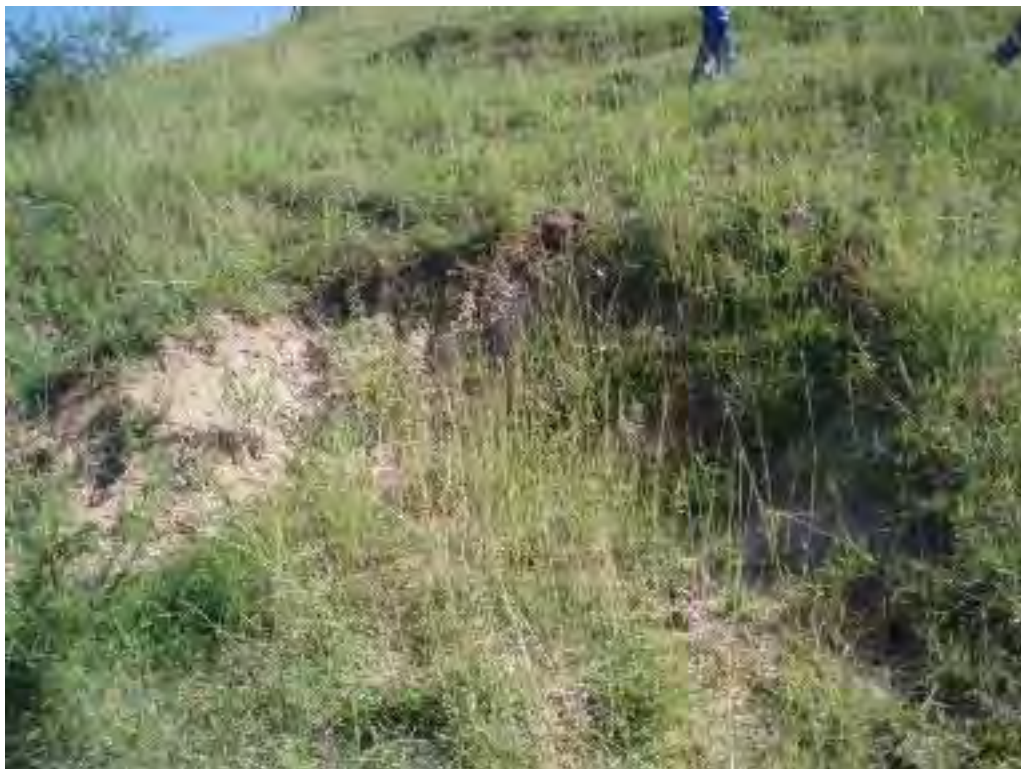
Multiple depressions were observed on the north and east embankment exterior slopes (Photos 28, 30, 31, 32, and 36). The depressions ranged in size from 4 to 8 feet long and up to 3 feet deep. The depressions appear to be grown in erosion rills because no displaced material was observed below the depressions. Multiple erosion rills were observed at the toe of the north embankment exterior slope (Photo 33, 34, and 36). The erosion rills ranged in size from 6 to 10 feet long and up to 3 feet deep.

Photo No. 33: Secondary Pond - North embankment exterior slope, looking at 10'Lx4'Wx3'D erosion rill. Note the brush in background.

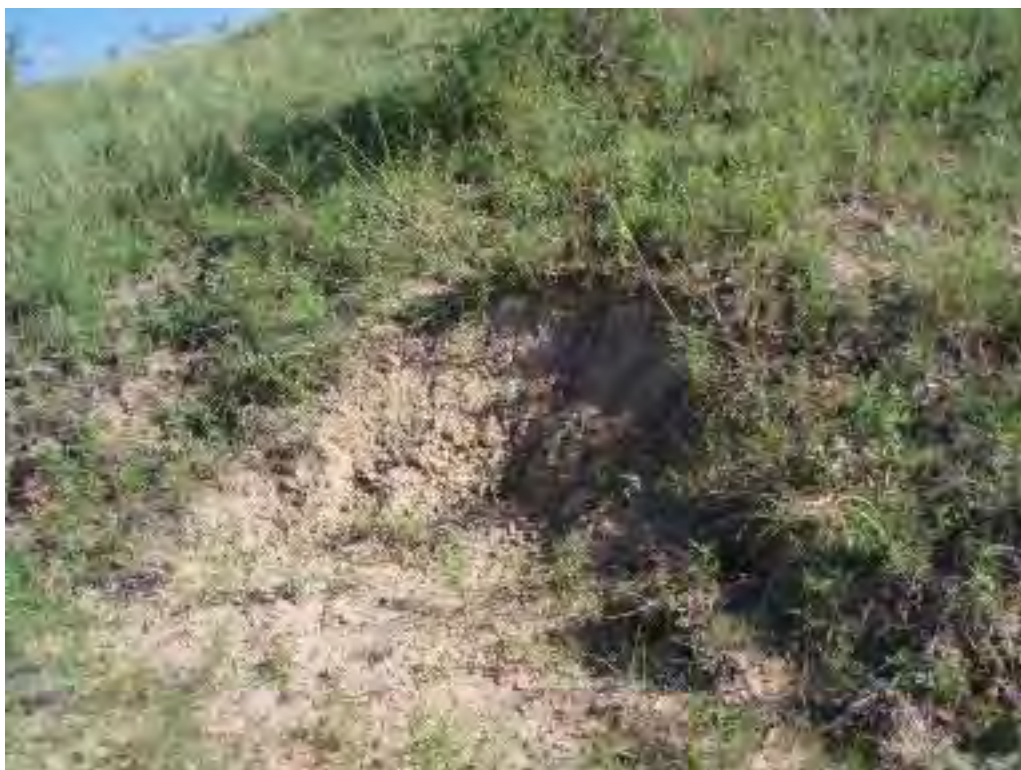
Photo No. 34: Secondary Pond - North embankment exterior slope, looking at 8'Lx4'Wx2'D erosion rill.

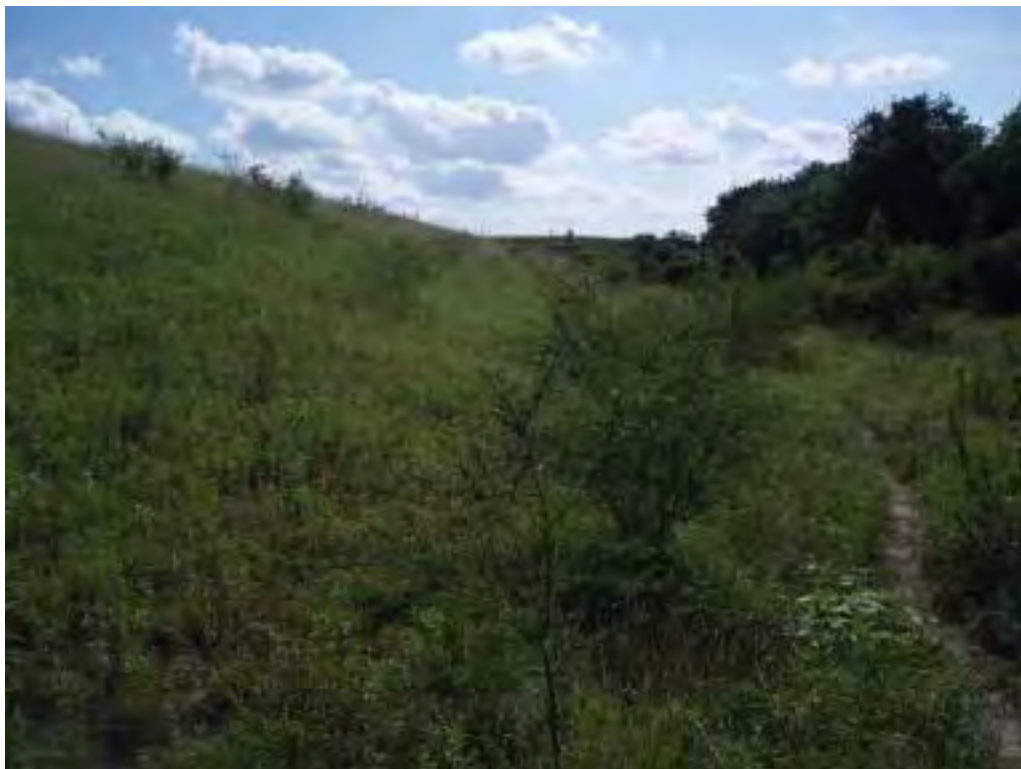
The exterior slopes appear to be in fair condition. The exterior slope on the north and east embankments were approximately 3H: 1V (Photos 18, 27, 29, 32, 35, 37, 38, and 40). Embankment vegetation consisted mainly of grass approximately 36 to 48 inches tall. On the east embankment, 8- to 12-inch-diameter dead mesquite trees and an area of thick brush were observed (Photos 27, 29 and 30). On the north embankment, small brush and mesquite trees less than 2 inches in diameter were observed (Photos 33 and 35).

Photo No. 35: Secondary Pond - North embankment exterior slope, looking west. Note trees and brush growing on the slope.

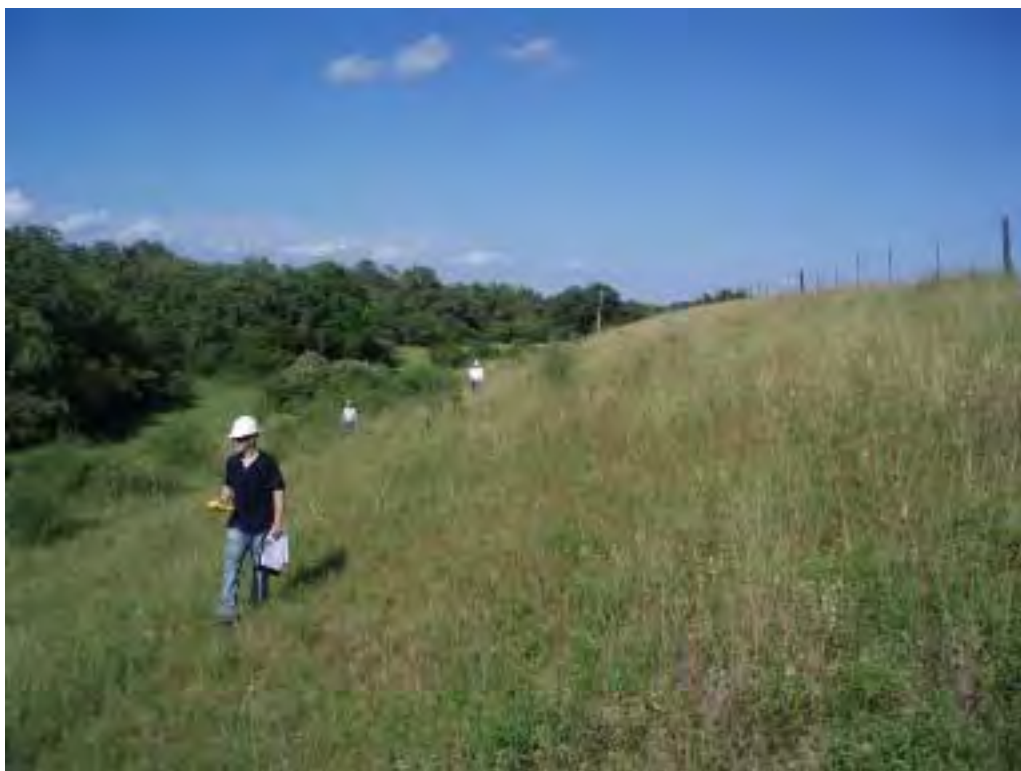
Photo No. 37: Secondary Pond - North embankment exterior slope, looking east.

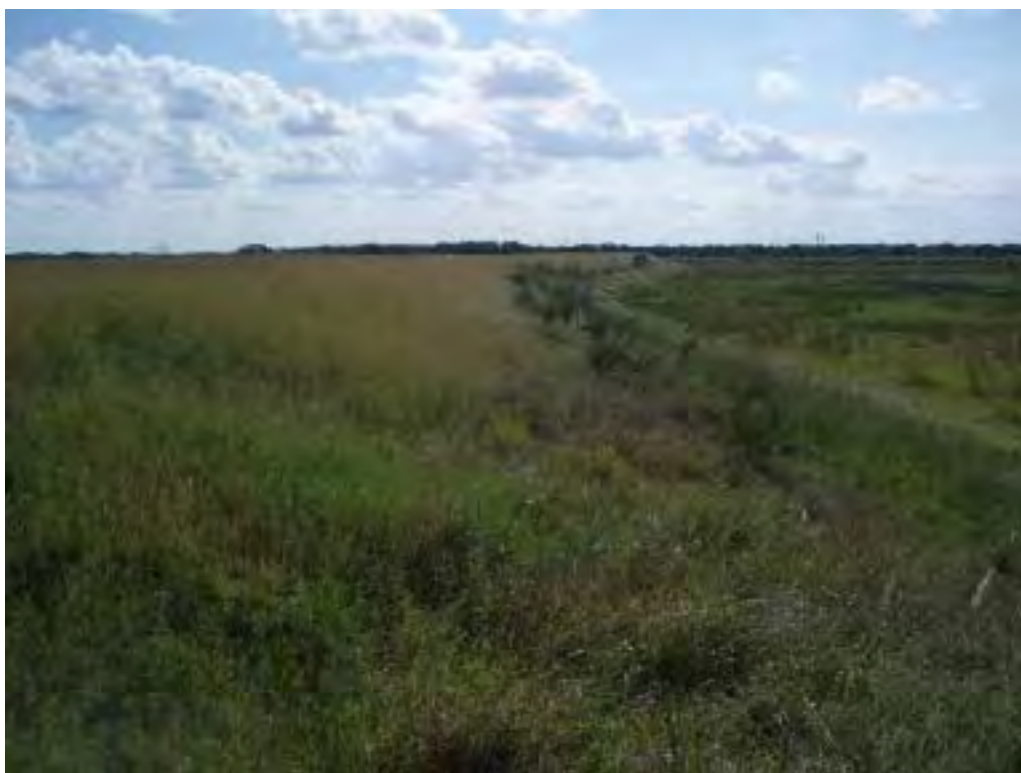
Photo No. 38: Secondary Pond - North embankment exterior slope, looking west.

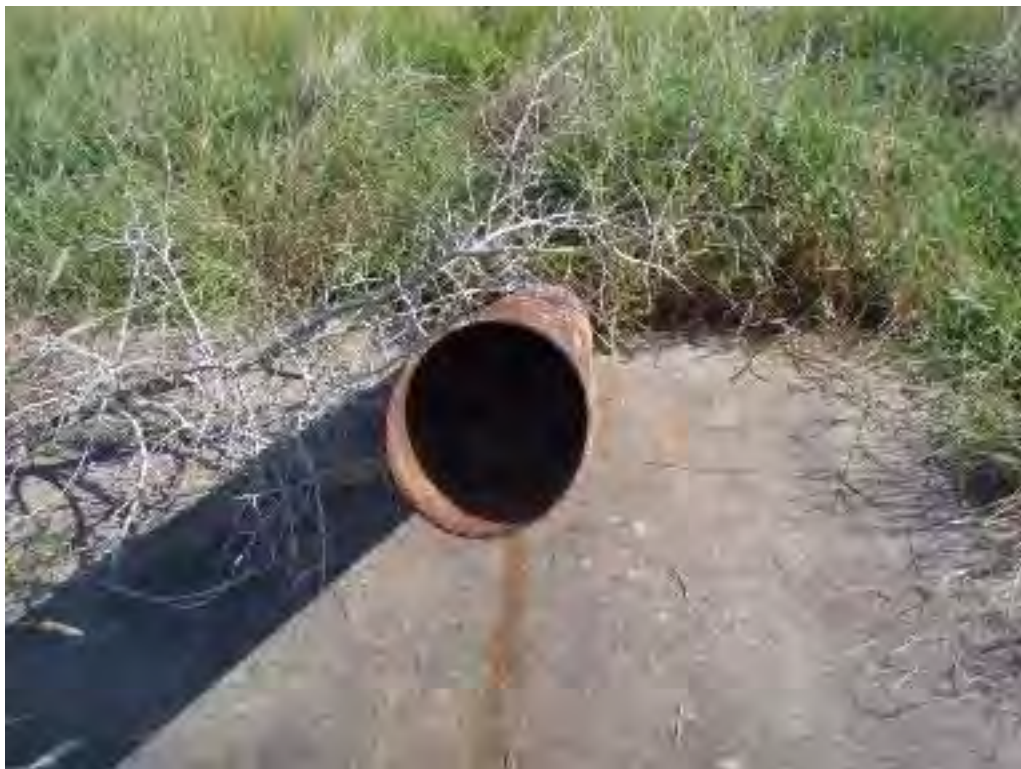
On the north embankment a 12-inch-diameter DI pipe was observed. Based on information from IPA personnel, an 8-inch-diameter pipe (Photos 1, 4, and 15) from the recirculating pump station conveys water back to the Secondary Pond or the outlet pipe located in the evaporation pond (Photo 39).

Photo No. 39: Secondary Pond, north embankment exterior slope, looking at 12-inch-diameter DI recirculating pipeline. Pipeline discharges from recirculating pump station into Evaporation Pond.

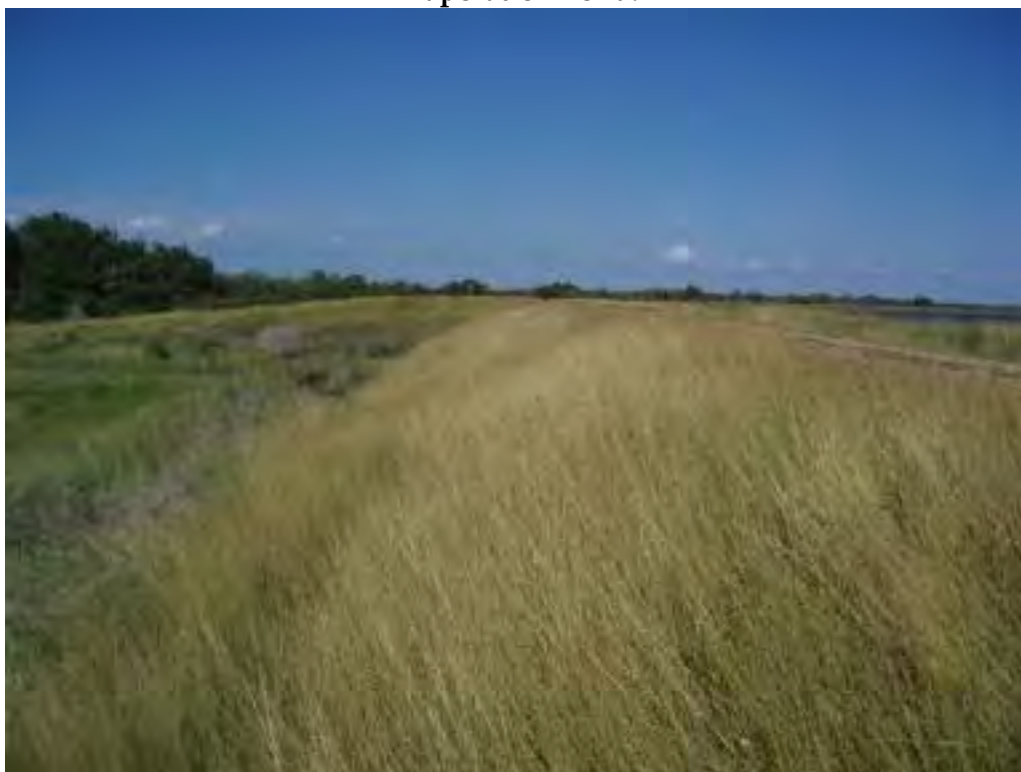
Photo No. 40: Secondary Pond – North embankment exterior slope, looking east.

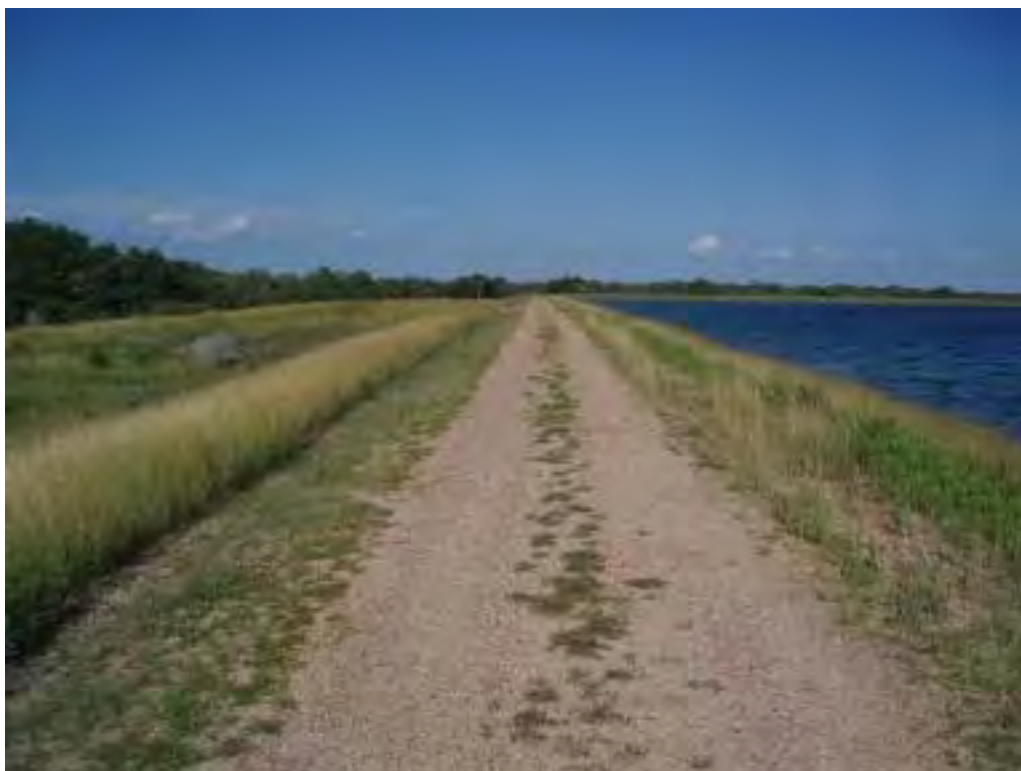
Photo No. 41: Secondary Pond - North embankment crest, looking east.

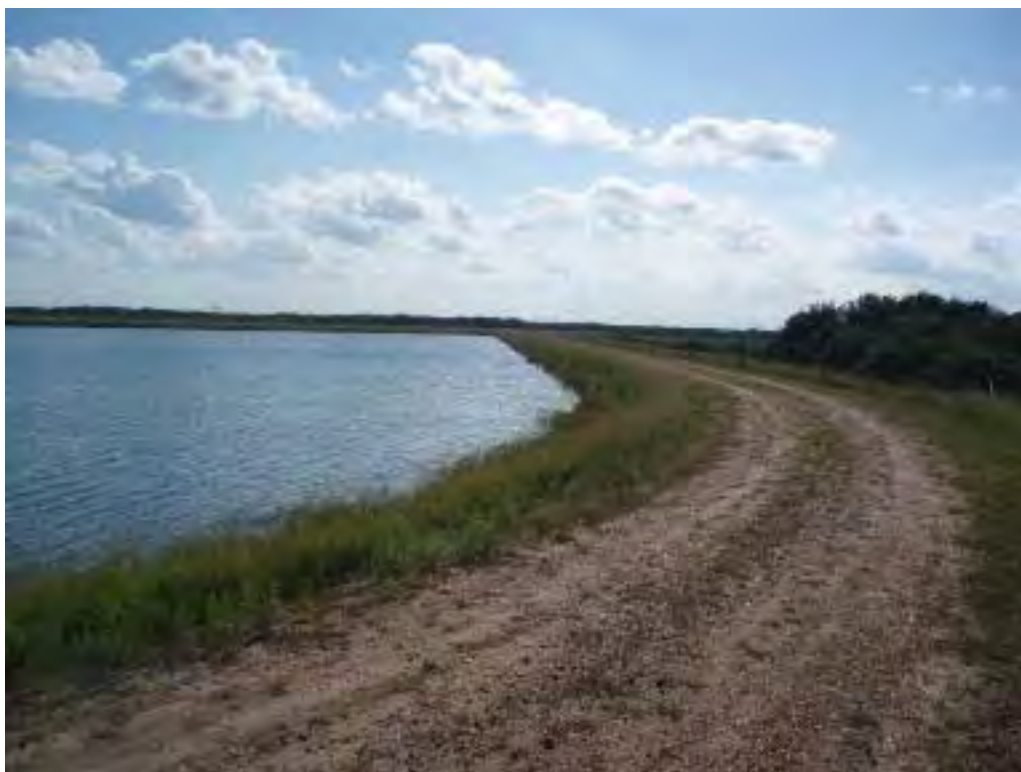
Photo No. 46: Secondary Pond - North embankment interior slope and crest, looking west.
